**Flood Control Project Maintenance
Levee Inspections**
LMA District Cover Sheet
Spring 2018 Levee Inspection Results

Reclamation District No. 1000 Natomas

Spring 2018 Levee Inspection Results

Waterway			Bank	Unit Miles
Unit No. 01 Sacramento River			Left	18.28
	Spring (March - May)	Summer (June - August)	(September - November) Fall	Winter (December - February)
Unit Maintenance Rating (Fall Only)				
Date of Inspection	3/14/2018 - 3/14/2018			
DWR Inspector	Sterling York			
Accompanied By	Don Caldwell RD1000

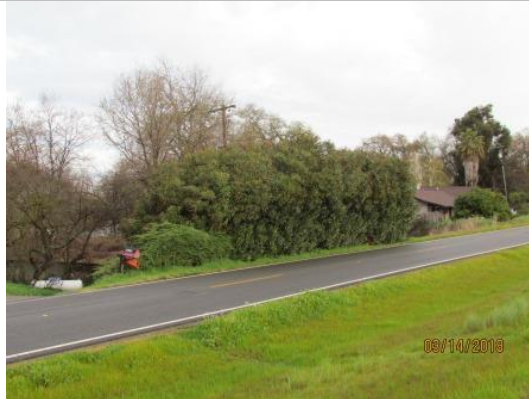
Photo 1 of 1 : SP_2018_RD1000_31_129_20180320_00048.jpg

LM Start	2.00	Rating **	U	Issue No.	129
LM End	2.01	Issue Type +	En	Location *	WS
Category	Earthen Levee			GPS Latitude/Longitude	
				Start	End
Item	Vegetation			38.753983 °	38.753848 °
				-121.591737 °	-121.591797 °
DWR ID	DWR_RD1000_01_s_2012_129				
Comment Code					
V6 : Landscaping					
Inspector Comment					
Landscape vegetation is blocking access and visibility to the levee, Spring 2018.

View looking upstream waterside of landscape vegetation that is blocking access and visibility to the levee, Spring 2018.

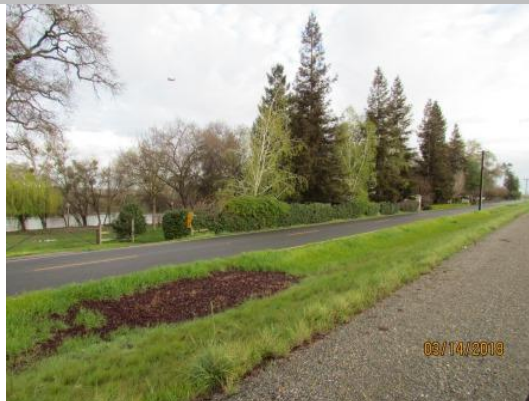
Photo 1 of 1 : SP_2018_RD1000_31_122_20180320_00049.jpg

LM Start	2.10	Rating **	M	Issue No.	122
LM End	2.16	Issue Type +	En	Location *	WS
Category	Earthen Levee			GPS Latitude/Longitude	
				Start	End
Item	Vegetation			38.752540 °	38.751822 °
				-121.592563 °	-121.592857 °
DWR ID	DWR_RD1000_01_s_2012_122				
Comment Code					
V6 : Landscaping					
Inspector Comment					
Landscape vegetation is blocking access and visibility to the levee, Spring 2018.

View looking upstream waterside of landscape vegetation that is blocking access and visibility to the levee, Spring 2018.

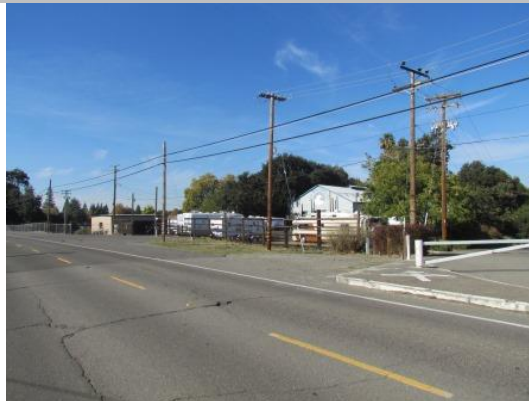
Photo 1 of 1 : SP_2018_RD1000_31_9_20180302_00008.jpg

LM Start	17.53	Rating **	U	Issue No.	9
LM End	17.56	Issue Type +	En	Location *	LS
Category	Earthen Levee			GPS Latitude/Longitude	
				Start	End
Item	Encroachments			38.605420 °	38.605462 °
				-121.524375 °	-121.523852 °
DWR ID	DWR_RD1000_01_s_2012_9				
Comment Code					
BU : Building					
Inspector Comment

This photo was taken from the crown facing upstream looking down the landward levee slope at an unacceptable building. Fall 2014.

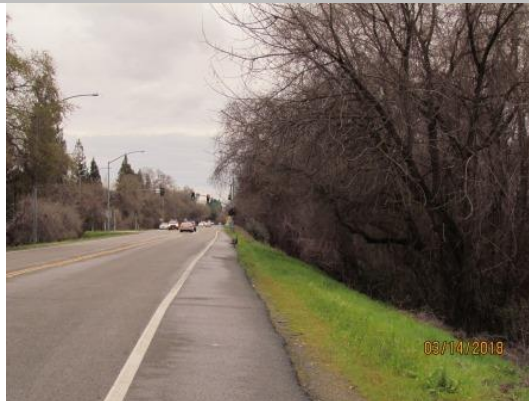
Photo 1 of 2 : SP_2018_RD1000_32_9_20180322_00012.jpg

LM Start	1.60	Rating **	A/W	Issue No.	9
LM End	2.23	Issue Type +	Ma	Location *	WS
Category	Earthen Levee			GPS Latitude/Longitude	
				Start	End
Item	Trim / Thin Trees			38.607683 °	38.605372 °
				-121.482819 °	-121.471962 °
DWR ID	DWR_RD1000_02_f_2017_9				
Comment Code					
T1 : Trim trees to at least five feet above ground level.					
Inspector Comment					
Trees have been trimmed for visibility and access, Spring 2018.

View of waterside looking upstream of trees that have been trimmed for visibility and access, Spring 2018.

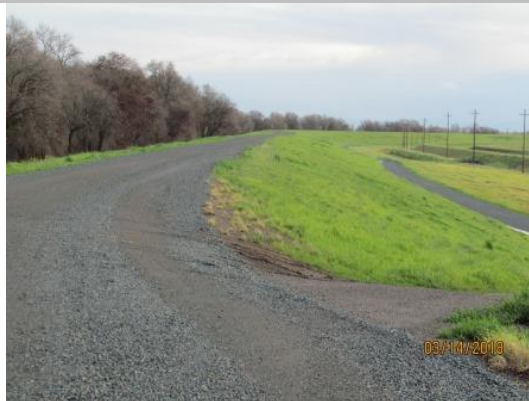
Photo 1 of 1 : SP_2018_RD1000_34_13_20180322_00001.jpg

LM Start	0.01	Rating **	A	Issue No.	13
LM End	4.27	Issue Type +	Ma	Location *	LS
Category	Earthen Levee			GPS Latitude/Longitude	
				Start	End
Item	Vegetation			38.820549 °	38.780935 °
				-121.543915 °	-121.603488 °
DWR ID	DWR_RD1000_04_s_2018_13				
Comment Code					
V1 : Control annual grass and weeds on the levee slopes and easements.					
Inspector Comment					
Annual vegetation is well maintained, Spring 2018.

View looking upstream landside of the well maintained annual vegetation, Spring 2018.
